# Cochlear explantation – surgical and audiological aspects

Cochlear explantation is rare in surgical practice; it can be due to medical conditions or device failure. According to literature data, there are some particularities to be expected in revision surgery. The authors describe a case of successful explantation followed by reimplantation, with excellent results, pointing out on the surgical difficulties encountered.

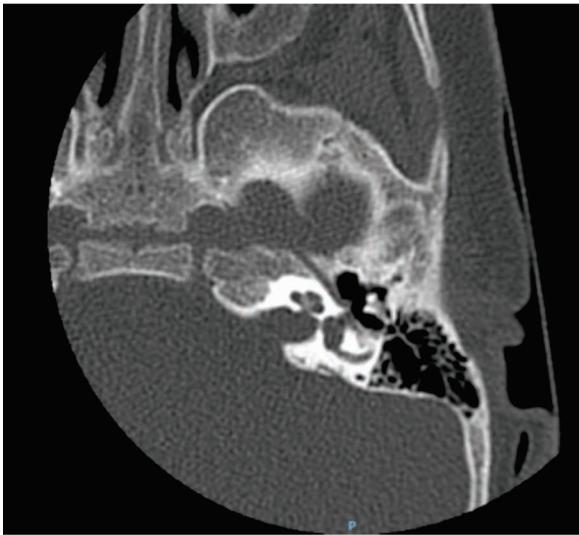
**FIGURE 1.** CT image before the first cochlear implantation (2019)

Our patient D.I. first presented to our department at the age of 2, with profound bilateral sensorineural hypoacusia and delay of language development, no other ENT or general pathology (besides allergy to amoxicillin-clavulanate). After complete audiological and imagistic investigations (CT – figure 1 and MRI) we decided and performed cochlear implantation in the left ear (Oticon device, november 2019). The postoperative evolution was fine, with activation of the implant at 5 weeks postoperatively; the child followed the fitting sessions and speech therapy recovery recommended by our protocole, with good understanding and speech development results.

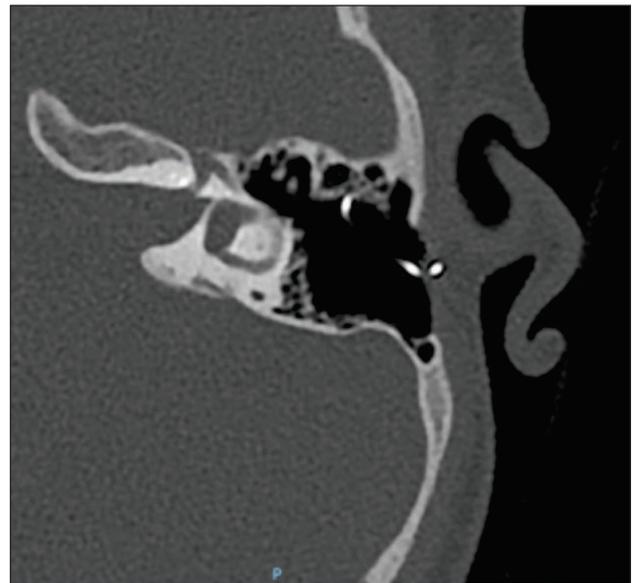
**FIGURE 3.** Osteoneogenesis is visible on CT images before explantation (new bone surrounding the electrode at the level of mastoid edge)

Suspecting a device malfunction we decided and performed cochlear explantation followed immediately by reimplantation with the same type of device (March 2021). The CT images performed preoperatively (figure 3) drew attention to the osteoneogenesis process in the mastoid cavity. In fact, immediately after incision of skin and subcutaneous tissues, we noticed intense fibrosis, and osteogenesis around the external part of the electrode, making dissection difficult (figure 4). After thorough dissection of fibrous tissue surrounding

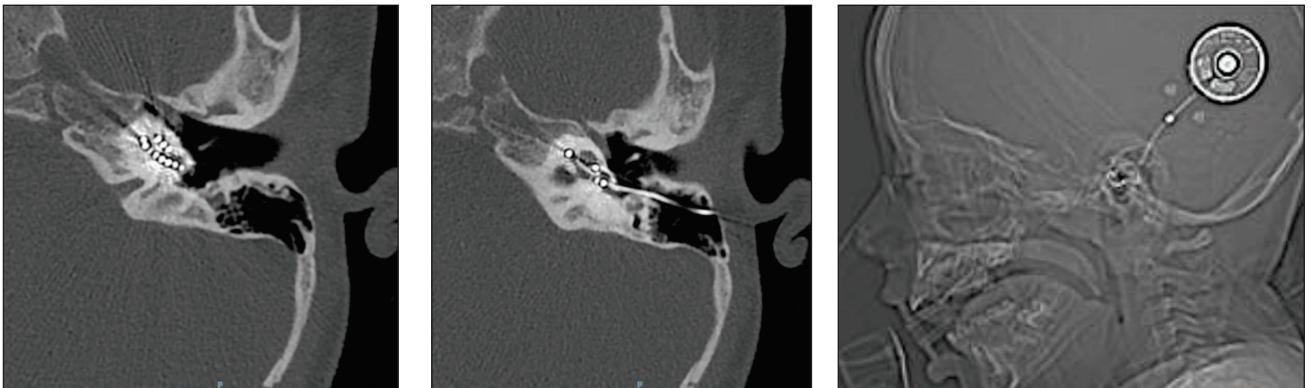
**FIGURE 2.** CT images (March 2021) showing intracochlear positioning of the electrode and no migration of the processor

In March 2021, at the age of 4, the child presents to our department, accusing decreased performance and speech perception with the implant for 2 months, in the absence of head trauma. The measured impedances of the implant's electrodes were fine, the CT performed in this case (March 2021) showed no migration of the electrode or internal processor (figure 2), there were no local changes of the left retroauricular area, the ENT exam was completely normal.

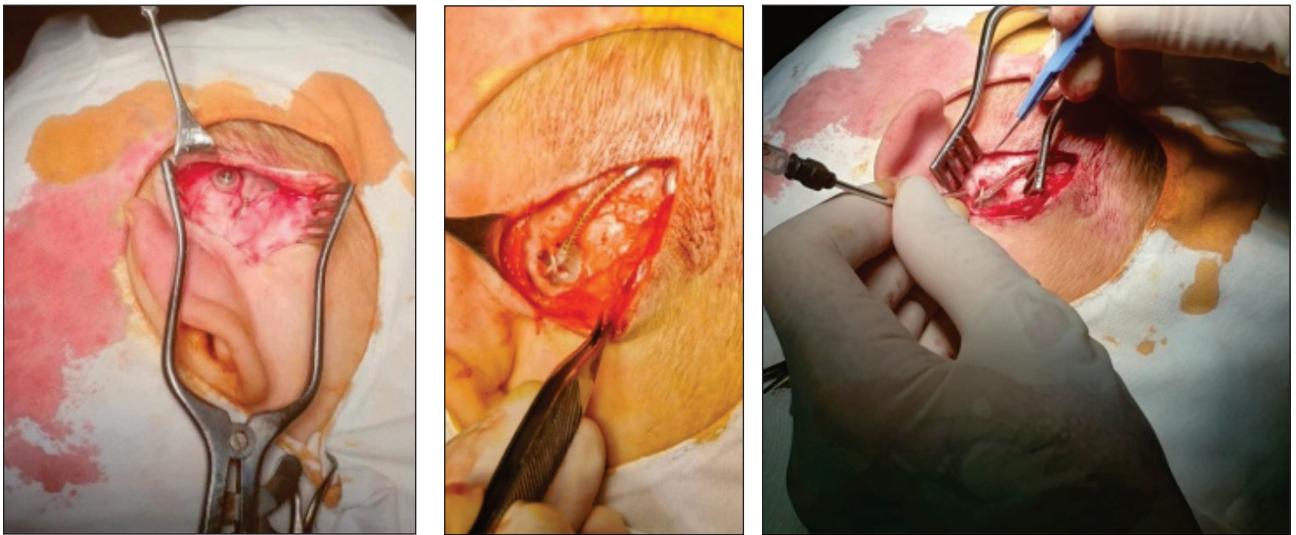
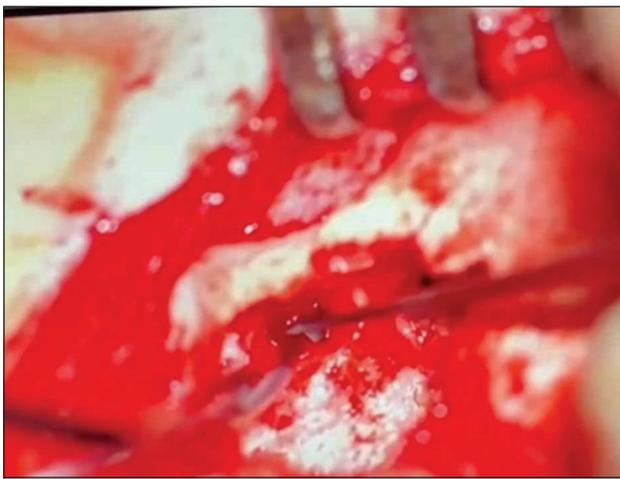
the electrode, the mastoid cavity was visible, significantly modified because of osteoneogenesis; new bone fixating the external part of the electrode at the edge of the mastoid cavity was carefully drilled, in order not to damage the implant; there was mild fibrosis at the level of the posterior tympanotomy and cochleostomy, needing fine dissection. The extraction of the electrode from the cochlea went smoothly. In order to minimise the time with open cochlea, we first extracted the old processor, leaving the electrode in place, then fixed the new processor with 2 screws in place, then removed the old electrode and inserted the new one (figure 5). Fine resistance was encountered at first attempt to insert the electrode through the cochleostomy (probably due to cochlear ossification), but after minimal drilling of the edge of the cochleostomy, the new electrode went in smoothly, with full insertion.

**FIGURE 4.** Intraoperative images during explantation showing intense fibrosis and osteoneogenesis in and around mastoid cavity

genesis, especially in children (8); in our case, the need to extract the implant without damaging it, in order to be technically analysed – added difficulty to the explantation. Intense fibrosis and remodeling of local tissues were common findings in this case, needing thorough dissection, drilling of the new bone at the mastoid cavity edge and at the cochleostomy level.

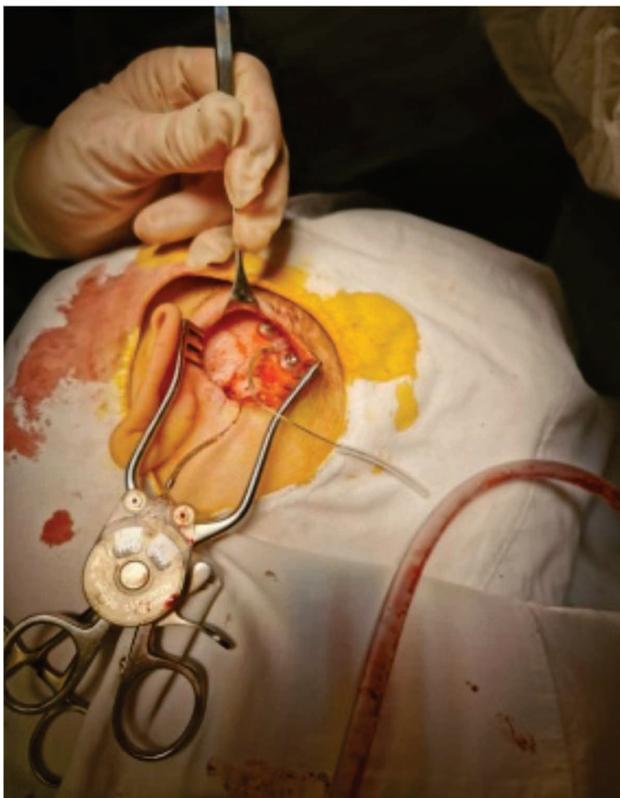
**FIGURE 5.** Intraoperative aspect – the old electrode remained in the cochlea while preparing the new device

In order to minimise the time during which the cochlea remained open – increasing the risk of infection - we first extracted the old processor, leaving the electrode in place until reinsertion of the new one.

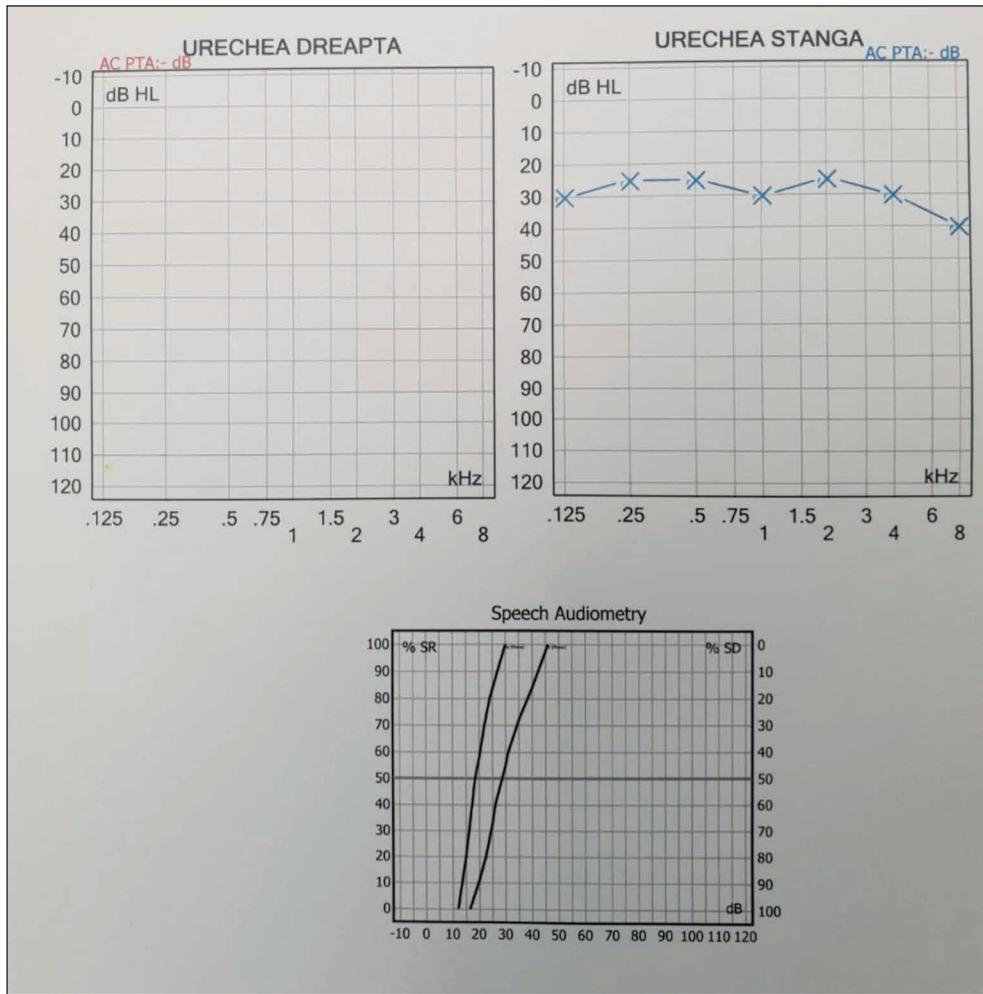
Intraoperative audiological measurements (NRTs, impedances) were good, accounting for correct insertion of the electrode. Postoperative evolution of the patient was uneventful, under intravenous antibiotic (Meropenem); he returned 4 weeks later to our audiology department for implant activation, with excellent results (figure 6); afterwards only 2 fitting sessions were needed in order to obtain normal hearing with the implant.

**FIGURE 6.** Free-field audiometry during first fitting session showing near-to-normal hearing with the implant

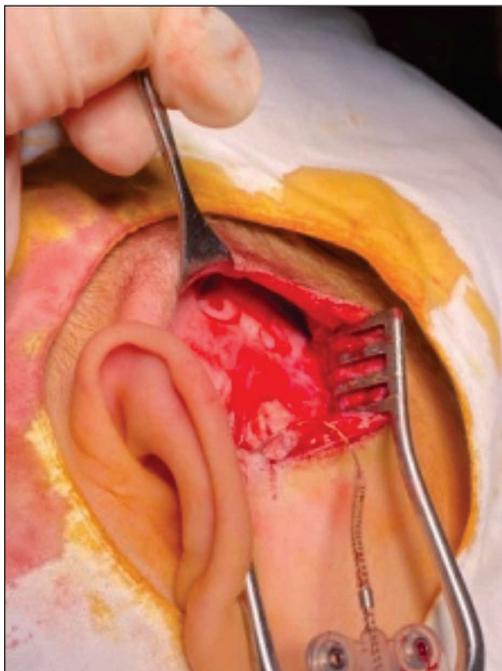
**FIGURE 7.** Previous implant bed and electrode groove

screws, after extracting the old device, we noticed a newly formed "implant bed" and electrode groove (figure 7), carved into the skull bone by the implant itself – another proof of bone plasticity in children.
