# COCHLEAR EXPLANTATION – SURGICAL AND AUDIOLOGICAL ASPECTS

## ABSTRACT

Cochlear explantation is rare in surgical practice; it can be due to medical conditions or device failure. According to literature datas, there are some particularities to be expected in revision surgery. The authors describe a case of successful explantation followed by reimplantation, with excellent results, pointing out on the surgical difficulties encountered.

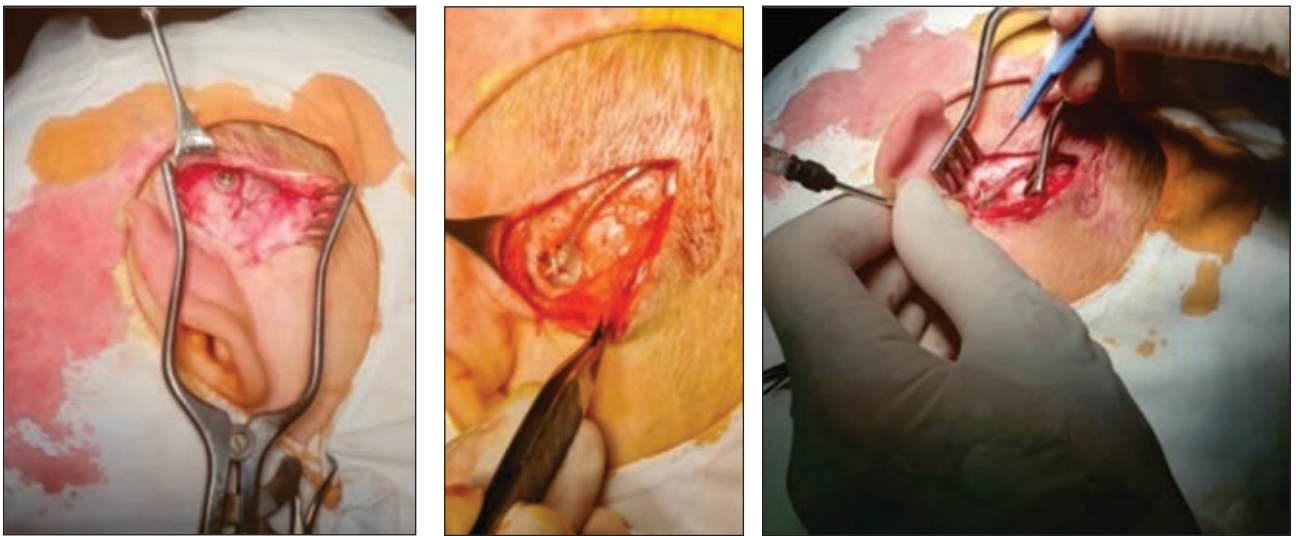
Suspecting a device malfunction we decided and performed cochlear explantation followed immediately by reimplantation with the same type of device (March 2021). The CT images performed preoperatively (figure 3) drew attention to the osteoneogenesis process in the mastoid cavity. In fact, immediately after incision of skin and subcutaneous tissues, we noticed intense fibrosis, and osteogenesis around the external part of the electrode, making dissection difficult (figure 4). After thorough dissection of fibrous tissue surrounding

the electrode, the mastoid cavity was visible, significantly modified because of osteoneogenesis; new bone fixating the external part of the electrode at the edge of the mastoid cavity was carefully drilled, in order not to damage the implant; there was mild fibrosis at the level of the posterior tympanotomy and cochleostomy, needing fine dissection. The extraction of the electrode from the cochlea went smoothly. In order to minimise the time with open cochlea, we first extracted the old processor, leaving the electrode in place, then fixed the new processor with 2 screws in place, then removed the old electrode and inserted the new one (figure 5). Fine resistance was encountered at first attempt to insert the electrode through the cochleostomy (probably due to cochlear ossification), but after minimal drilling of the edge of the cochleostomy, the new electrode went in smoothly, with full insertion.

**FIGURE 4.** Intraoperative images during explantation showing intense fibrosis and osteoneogenesis in and around mastoid cavity

need to extract the implant without damaging it, in order to be technically analysed – added difficulty to the explantation. Intense fibrosis and remodeling of local tissues were common findings in this case, needing thorough dissection, drilling of the new bone at the mastoid cavity edge and at the cochleostomy level.

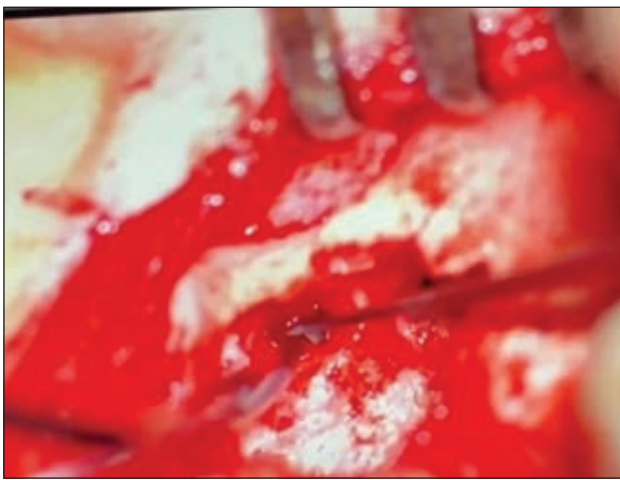
**FIGURE 5.** Intraoperative aspect – the old electrode remained in the cochlea while preparing the new device

In order to minimise the time during which the cochlea remained open – increasing the risk of infection - we first extracted the old processor, leaving the electrode in place until reinsertion of the new one.

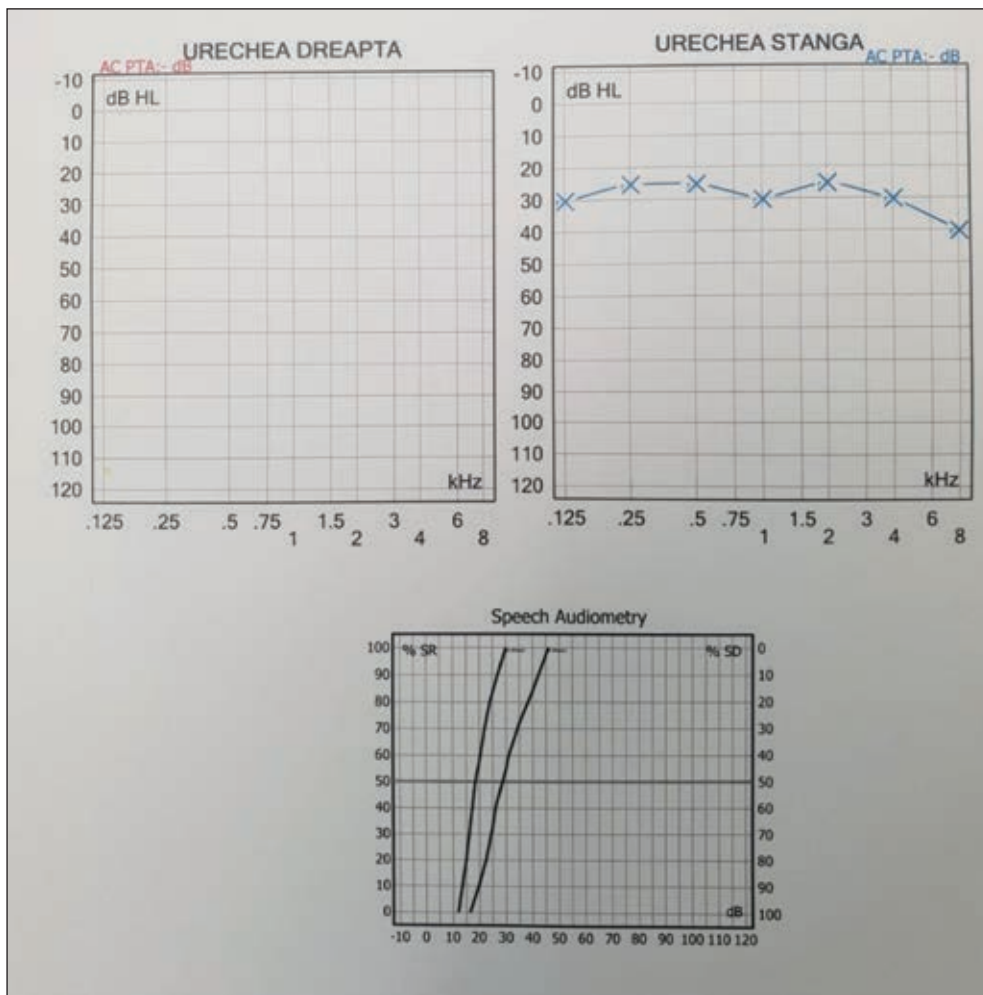
correct insertion of the electrode. Postoperative evolution of the patient was uneventful, under intravenous antibiotic (Meropenem); he returned 4 weeks later to our audiology department for implant activation, with excellent results (figure 6); afterwards only 2 fitting sessions were needed in order to obtain normal hearing with the implant.

**FIGURE 6.** Free-field audiometry during first fitting session showing near-to-normal hearing with the implant

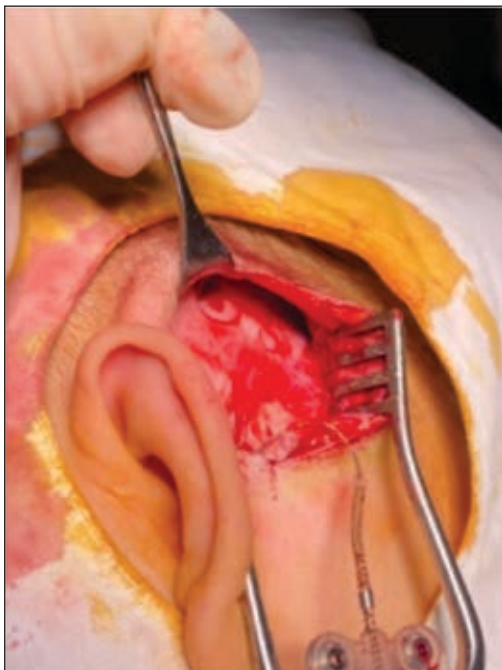
**FIGURE 7.** Previous implant bed and electrode groove

Although there is no need for implant bed drilling with Oticon devices, which are fixed with 2 screws, after extracting the old device, we noticed

a newly formed "implant bed" and electrode groove (figure 7), carved into the skull bone by the implant itself – another proof of bone plasticity in children.
